CLIENT:  
NORTHERN GATEWAY PIPELINES INC.

STUART RIVER CROSSING

GEOTECHNICAL ENGINEERING  
RISK-BASED DESIGN APPROACH  
ENBRIDGE NORTHERN GATEWAY PROJECT

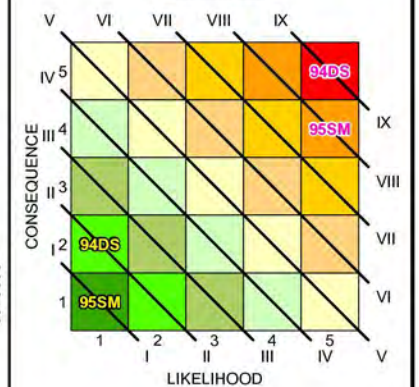
### Risk Matrix

- Mass Wasting**
- DS Deep-seated slides
  - SM Shallow to moderately deep slides
  - DF Debris Flow
  - RF Rock Fall
  - AV Avalanches
  - LS Lateral Spreading
  - SE Stream Erosion & sedimentation
  - ER Wind & shallow stream or overland erosion
- Settlement**
- CS Consolidation Settlement
  - KS Karst induced Settlement or displacement
- Seismic**
- EQ Seismic Motion
  - LQ Liquefaction
- Tsunamis**
- TS Tsunamis
- (#) Number of occurrences of Geohazard that fit in that square of the Risk Matrix
